Home Report

Single Survey

Property address	54 Fishers Road Port Seton Prestonpans EH32 0ET
-------------------------	--

PART 1 - GENERAL

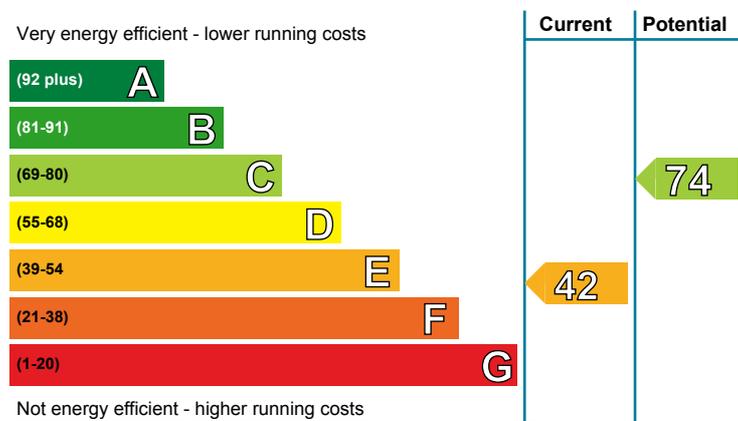
Energy Efficiency Rating

This graph shows the current efficiency of your home, taking into account both energy efficiency and fuel costs. The higher this rating, the lower your fuel bills are likely to be.

Your current rating is **band E (42)**. The average rating for EPCs in Scotland is **band D (61)**.

The potential rating shows the effect of undertaking all of the improvement measures listed within your recommendations report.

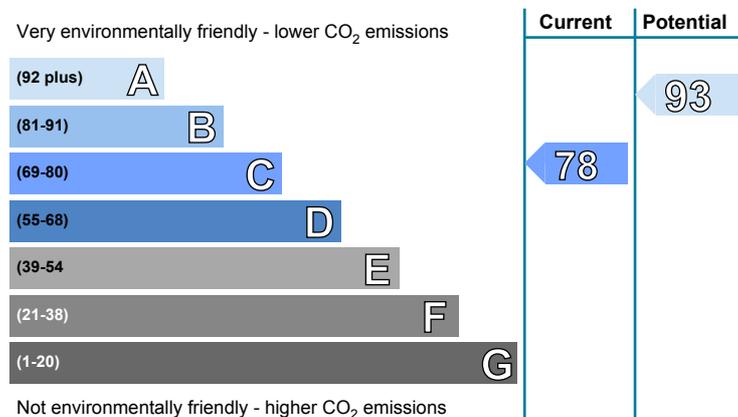
Environmental Impact (CO₂) Rating

This graph shows the effect of your home on the environment in terms of carbon dioxide (CO₂) emissions. The higher the rating, the less impact it has on the environment.
