7 NETHER CURRIE PLACE  
EDINBURGH  
CURRIE  
EH14 5JF

# Home Report

# Energy Performance Certificate

# Scottish Single Survey

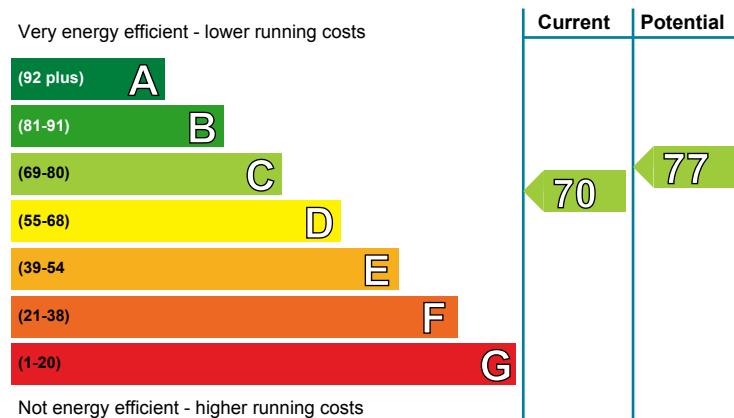
### Energy Efficiency Rating

This graph shows the current efficiency of your home, taking into account both energy efficiency and fuel costs. The higher this rating, the lower your fuel bills are likely to be.

Your current rating is **band C (70)**. The average rating for EPCs in Scotland is **band D (61)**.

The potential rating shows the effect of undertaking all of the improvement measures listed within your recommendations report.

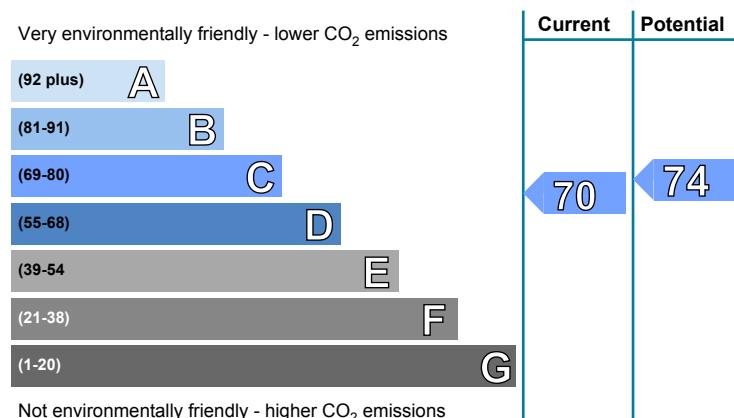
### Environmental Impact (CO<sub>2</sub>) Rating

This graph shows the effect of your home on the environment in terms of carbon dioxide (CO<sub>2</sub>) emissions. The higher the rating, the less impact it has on the environment.

Your current rating is **band C (70)**

The potential rating shows the effect of undertaking all of the improvement measures listed within your recommendations report.

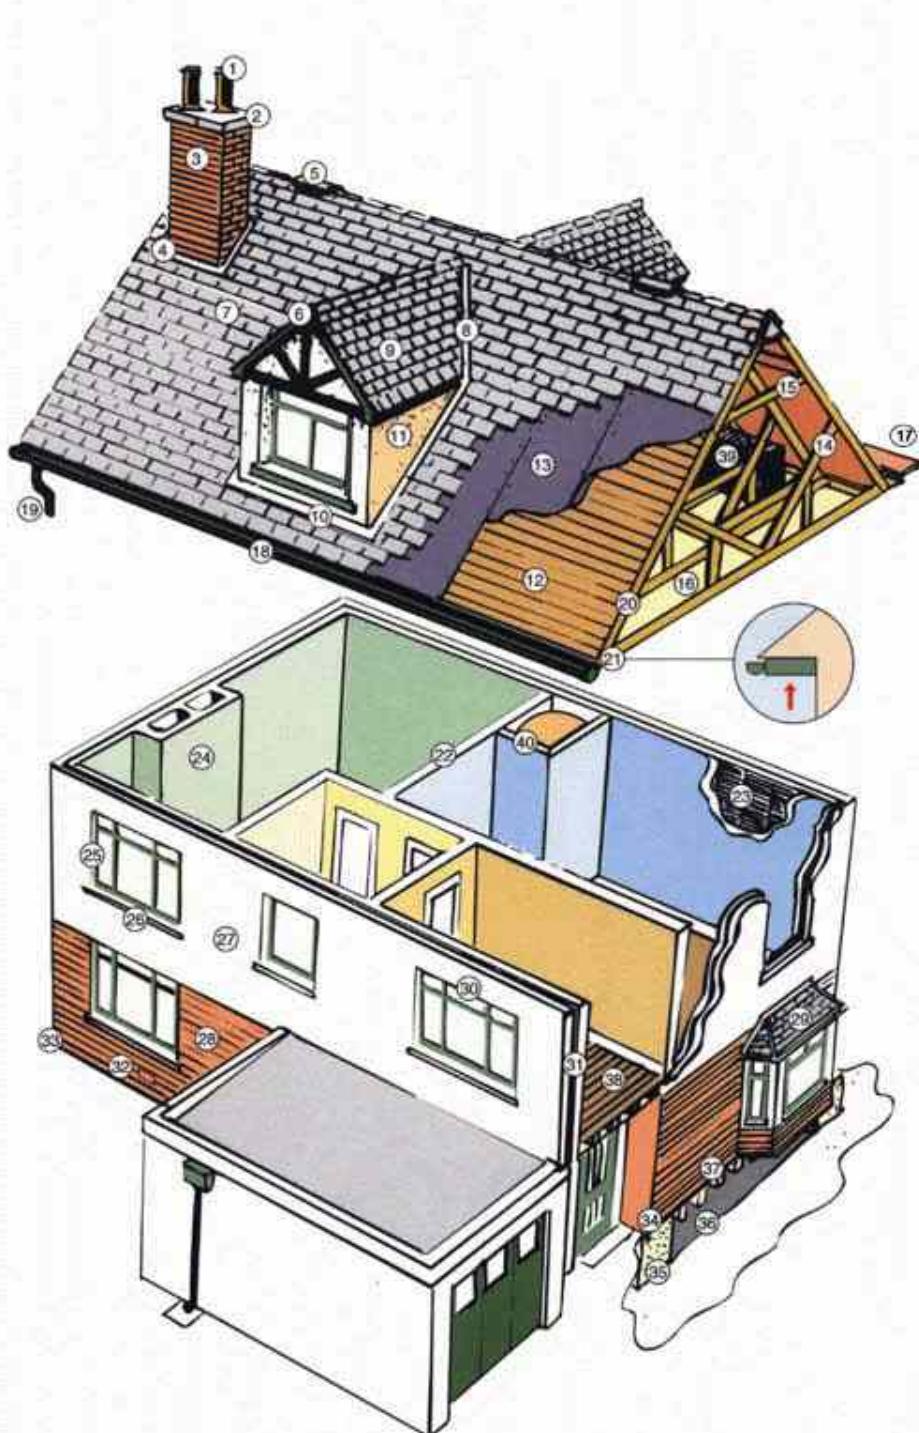
## Sectional Diagram showing elements of a typical house

- 1 Chimney pots
- 2 Coping stone
- 3 Chimney head
- 4 Flashing
- 5 Ridge ventilation
- 6 Ridge board
- 7 Slates / tiles
- 8 Valley guttering
- 9 Dormer projection
- 10 Dormer flashing
- 11 Dormer cheeks
- 12 Sarking
- 13 Roof felt
- 14 Trusses
- 15 Collar
- 16 Insulation
- 17 Parapet gutter
- 18 Eaves guttering
- 19 Rainwater downpipe
- 20 Verge boards /skews
- 21 Soffit boards
- 22 Partition wall
- 23 Lath / plaster
- 24 Chimney breast
- 25 Window pointing
- 26 Window sills
- 27 Rendering
- 28 Brickwork / pointing
- 29 Bay window projection
- 30 Lintels
- 31 Cavity walls / wall ties
- 32 Subfloor ventilator
- 33 Damp proof course
- 34 Base course
- 35 Foundations
- 36 Solum
- 37 Floor joists
- 38 Floorboards
- 39 Water tank
- 40 Hot water tank

Reference may be made in this report to some or all of the above component parts of the property. This diagram may assist you in locating and understanding these items.
