Home Report

Scottish Single Survey

Single Survey

Property address	27 Craigentinny Crescent Edinburgh EH7 6QA
-------------------------	--

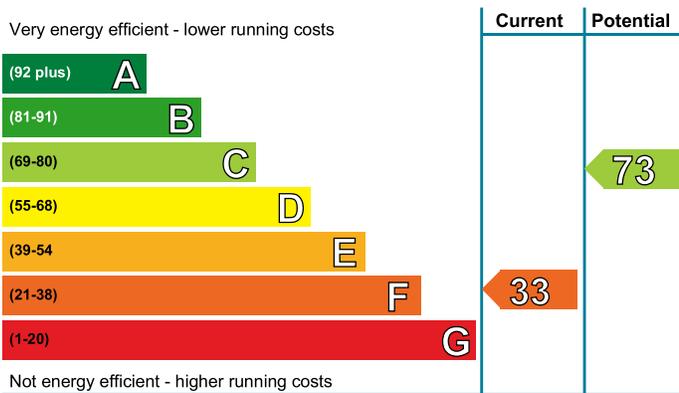
Energy Efficiency Rating

This graph shows the current efficiency of your home, taking into account both energy efficiency and fuel costs. The higher this rating, the lower your fuel bills are likely to be.

Your current rating is **band F (33)**. The average rating for EPCs in Scotland is **band D (61)**.

The potential rating shows the effect of undertaking all of the improvement measures listed within your recommendations report.

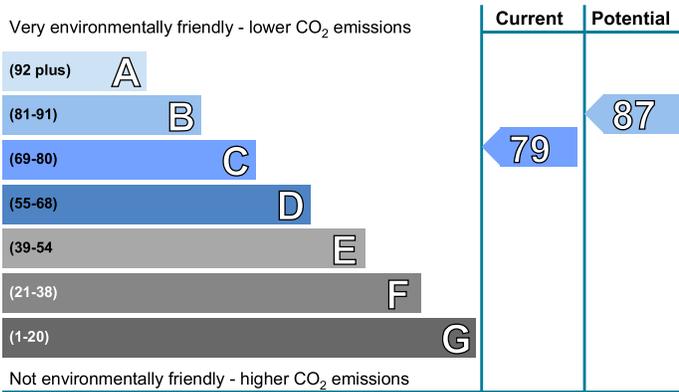
Environmental Impact (CO₂) Rating

This graph shows the effect of your home on the environment in terms of carbon dioxide (CO₂) emissions. The higher the rating, the less impact it has on the environment.
