Home Report

10(3F1) Kirk Street
Edinburgh EH6 5EY

Single Survey

Property Address	10(3F1) Kirk Street Edinburgh EH6 5EY
Customer	Duncan Durbin
Prepared by	Graham + Sibbald Property Consultants Limited
Date of Inspection	02/02/2026

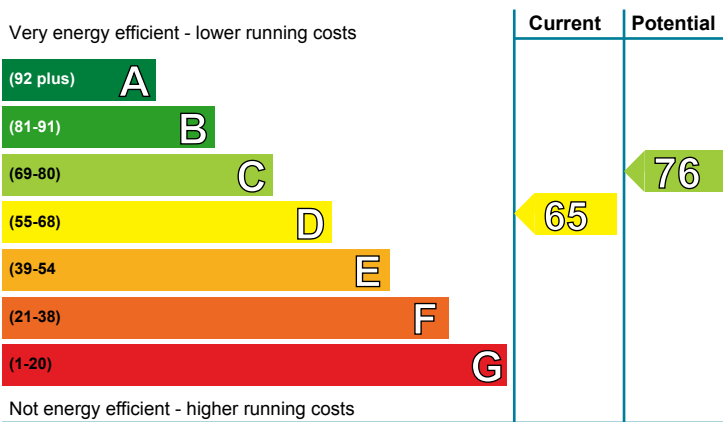
Energy Efficiency Rating

This graph shows the current efficiency of your home, taking into account both energy efficiency and fuel costs. The higher this rating, the lower your fuel bills are likely to be.

Your current rating is **band D (65)**. The average rating for EPCs in Scotland is **band D (61)**.

The potential rating shows the effect of undertaking all of the improvement measures listed within your recommendations report.

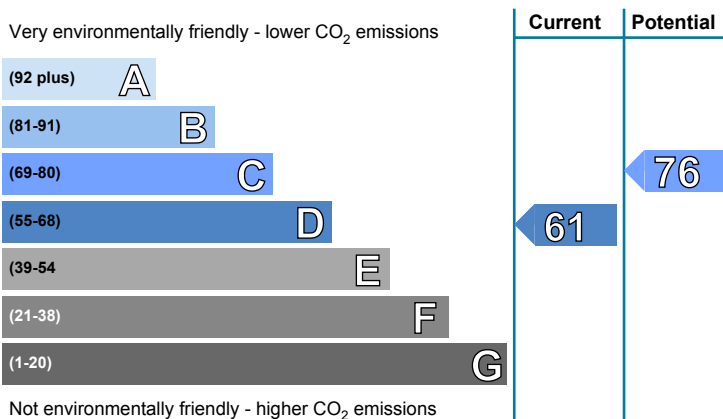
Environmental Impact (CO₂) Rating

This graph shows the effect of your home on the environment in terms of carbon dioxide (CO₂) emissions. The higher the rating, the less impact it has on the environment.
