YOUR ONESURVEY
HOME REPORT

10 Brucefield Avenue
Dunfermline
KY11 4SX

SINGLE SURVEY

Single Survey

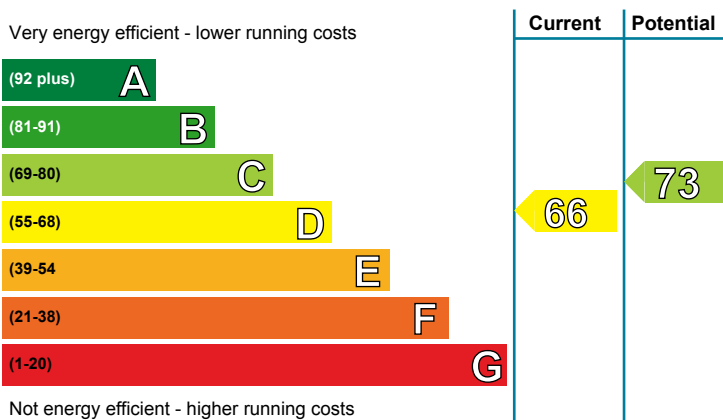
Energy Efficiency Rating

This graph shows the current efficiency of your home, taking into account both energy efficiency and fuel costs. The higher this rating, the lower your fuel bills are likely to be.

Your current rating is **band D (66)**. The average rating for EPCs in Scotland is **band D (61)**.

The potential rating shows the effect of undertaking all of the improvement measures listed within your recommendations report.

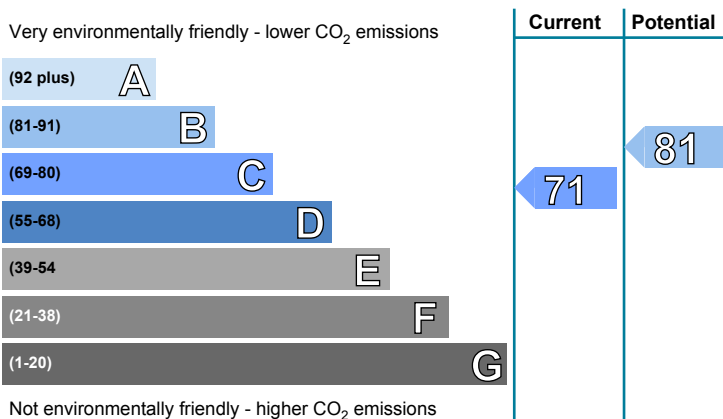
Environmental Impact (CO₂) Rating

This graph shows the effect of your home on the environment in terms of carbon dioxide (CO₂) emissions. The higher the rating, the less impact it has on the environment.
