Home Report

Contents

Single Survey

Property address	78 Thistle Street Dunfermline KY12 0JA
Customer	Gordon and Janice Mitchell
Customer address	78 Thistle Street Dunfermline KY12 0JA
Prepared by	Shepherd Chartered Surveyors
Date of inspection	06/03/2026

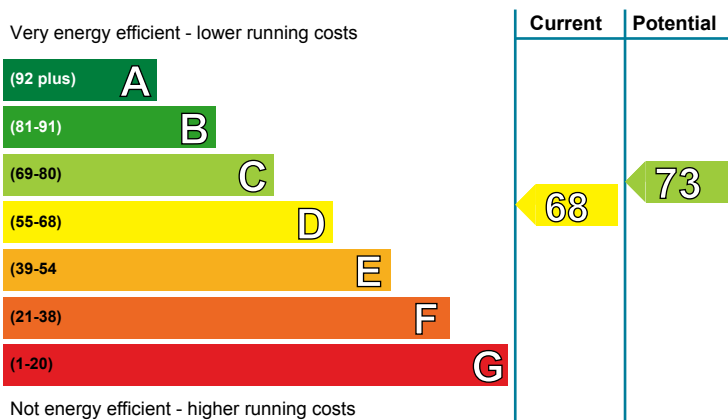
Energy Efficiency Rating

This graph shows the current efficiency of your home, taking into account both energy efficiency and fuel costs. The higher this rating, the lower your fuel bills are likely to be.

Your current rating is **band D (68)**. The average rating for EPCs in Scotland is **band D (61)**.

The potential rating shows the effect of undertaking all of the improvement measures listed within your recommendations report.
