# Home Report

# Scottish Single Survey

| <b>Property address</b> | 6 Lingerwood Farm Cottages<br>Newtongrange<br>Dalkeith<br>EH22 4TW |

| <b>Date of inspection</b> | 10/03/2026 |

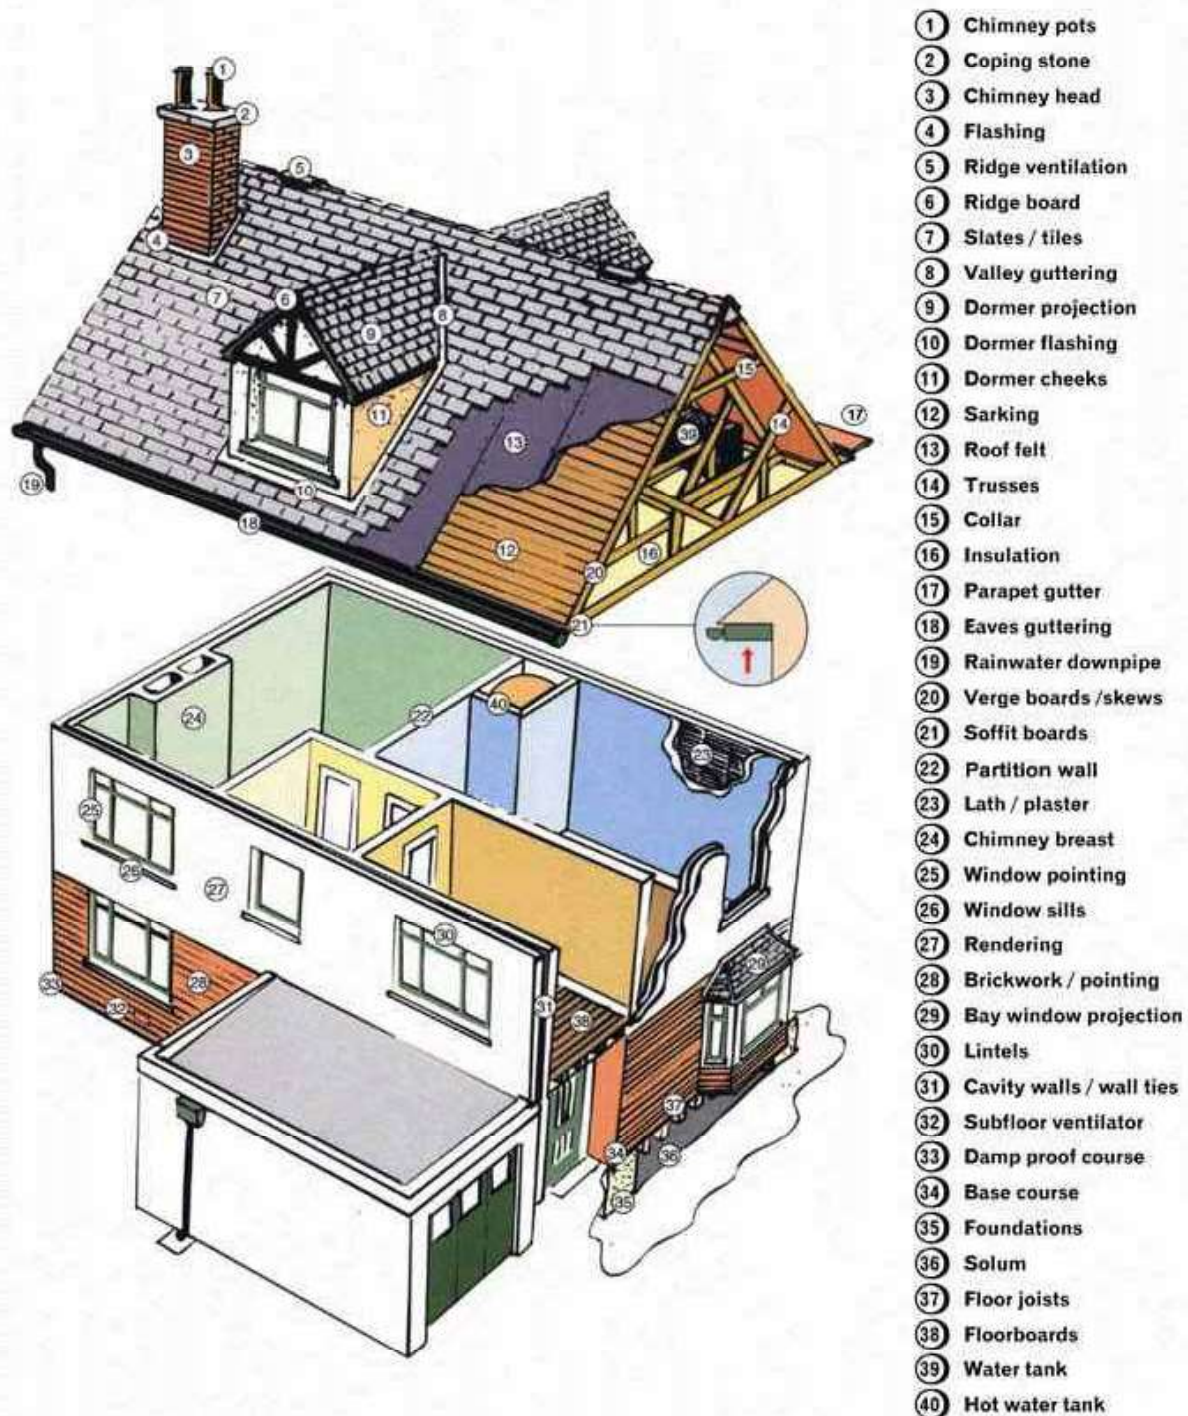
## Sectional Diagram showing elements of a typical house

Reference may be made in this report to some or all of the above component parts of the property. This diagram may assist you in locating and understanding these items.

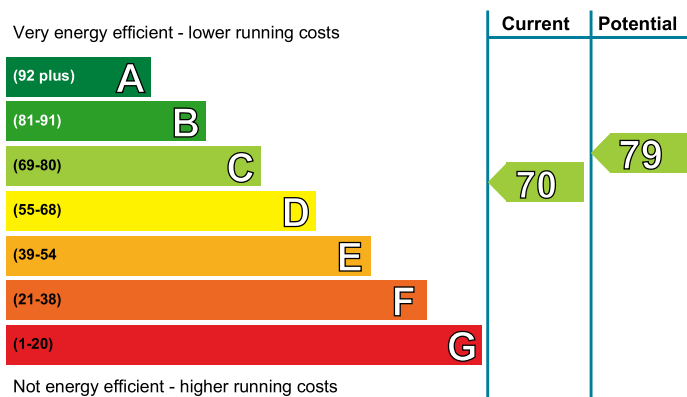
## Energy Efficiency Rating

This graph shows the current efficiency of your home, taking into account both energy efficiency and fuel costs. The higher this rating, the lower your fuel bills are likely to be.

Your current rating is **band C (70)**. The average rating for EPCs in Scotland is **band D (61)**.

The potential rating shows the effect of undertaking all of the improvement measures listed within your recommendations report.

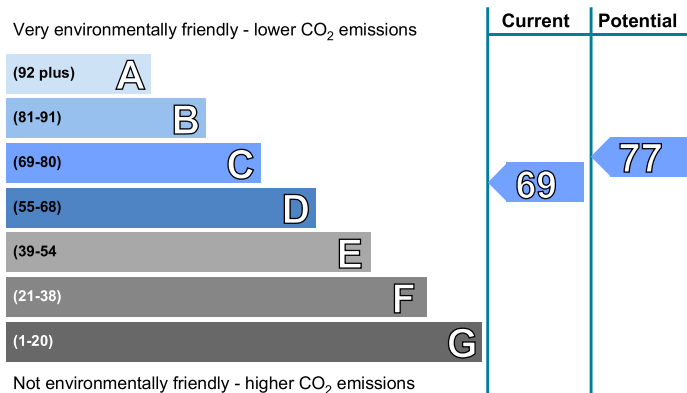
## Environmental Impact (CO<sub>2</sub>) Rating

This graph shows the effect of your home on the environment in terms of carbon dioxide (CO<sub>2</sub>) emissions. The higher the rating, the less impact it has on the environment.
