# Home Report

5 Comely Bank Terrace  
Edinburgh EH4 1AT

# Single Survey

| <b>Prepared by</b> | Graham + Sibbald Property Consultants Limited |

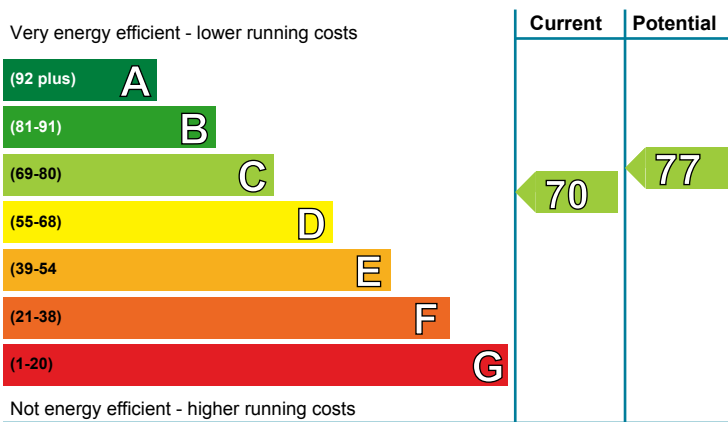
## Energy Efficiency Rating

This graph shows the current efficiency of your home, taking into account both energy efficiency and fuel costs. The higher this rating, the lower your fuel bills are likely to be.

Your current rating is **band C (70)**. The average rating for EPCs in Scotland is **band D (61)**.

The potential rating shows the effect of undertaking all of the improvement measures listed within your recommendations report.

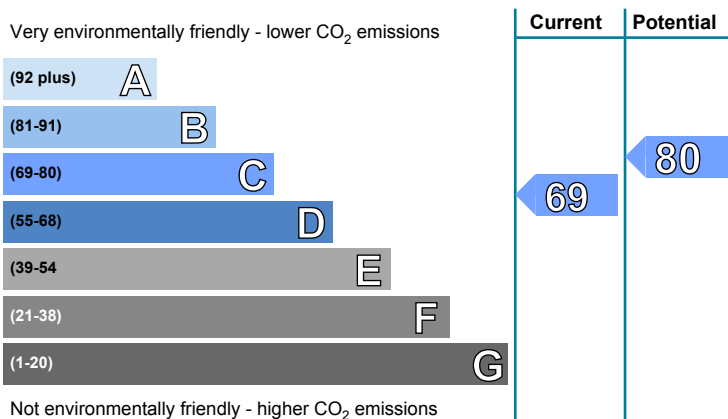
## Environmental Impact (CO<sub>2</sub>) Rating

This graph shows the effect of your home on the environment in terms of carbon dioxide (CO<sub>2</sub>) emissions. The higher the rating, the less impact it has on the environment.
