Home Report

48(2F1) Jordan Lane
Edinburgh EH10 4QX

Single Survey

Property Address	48(2F1) Jordan Lane Edinburgh EH10 4QX
Customer	The estate of the late Robert Anstruther
Prepared by	Graham + Sibbald Property Consultants Limited
Date of Inspection	08/04/2026

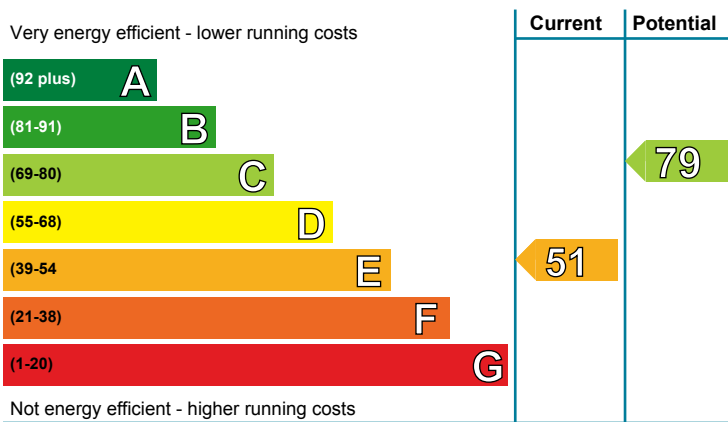
Energy Efficiency Rating

This graph shows the current efficiency of your home, taking into account both energy efficiency and fuel costs. The higher this rating, the lower your fuel bills are likely to be.

Your current rating is **band E (51)**. The average rating for EPCs in Scotland is **band D (61)**.

The potential rating shows the effect of undertaking all of the improvement measures listed within your recommendations report.

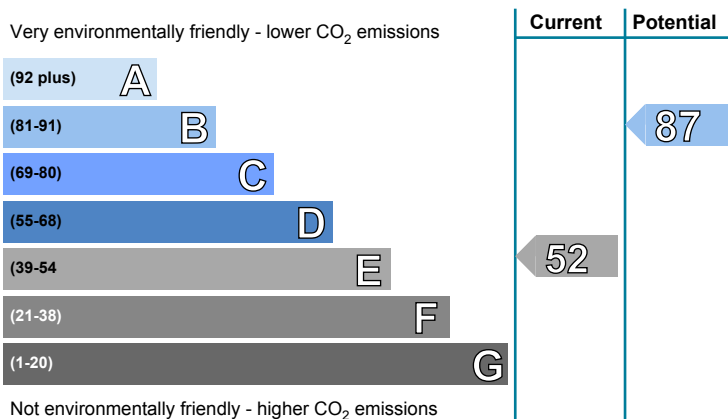
Environmental Impact (CO₂) Rating

This graph shows the effect of your home on the environment in terms of carbon dioxide (CO₂) emissions. The higher the rating, the less impact it has on the environment.
