Home Report

67/6 Cumberland Street
Edinburgh EH3 6RD

Single Survey

Property Address	67/6 Cumberland Street Edinburgh EH3 6RD
Customer	The estate of the late Janet Graham
Prepared by	Graham + Sibbald Property Consultants Limited
Date of Inspection	22/04/2026

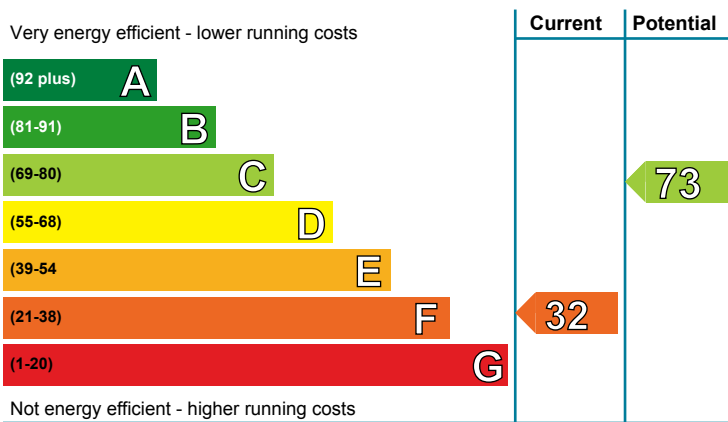
Energy Efficiency Rating

This graph shows the current efficiency of your home, taking into account both energy efficiency and fuel costs. The higher this rating, the lower your fuel bills are likely to be.

Your current rating is **band F (32)**. The average rating for EPCs in Scotland is **band D (61)**.

The potential rating shows the effect of undertaking all of the improvement measures listed within your recommendations report.

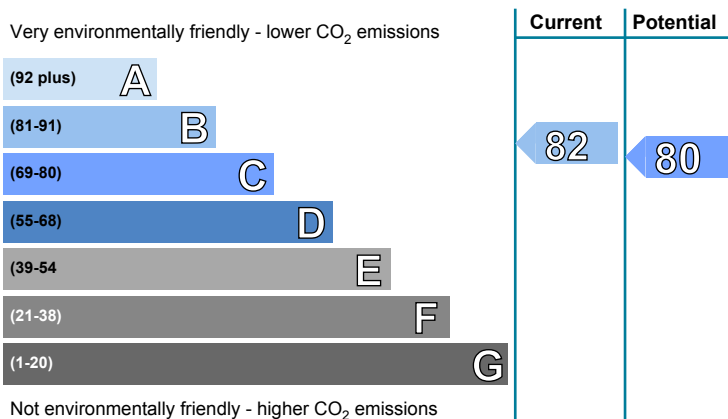
Environmental Impact (CO₂) Rating

This graph shows the effect of your home on the environment in terms of carbon dioxide (CO₂) emissions. The higher the rating, the less impact it has on the environment.
