# Home Report

# Scottish Single Survey

<b>Property address</b>	24 Kings Road Rosyth Dunfermline KY11 2SP
<b>Customer</b>	Brian Machray & Lucie Martin
<b>Customer address</b>	24 Kings Road Rosyth Dunfermline KY11 2SP
<b>Prepared by</b>	Shepherd Chartered Surveyors
<b>Date of inspection</b>	24/04/2026

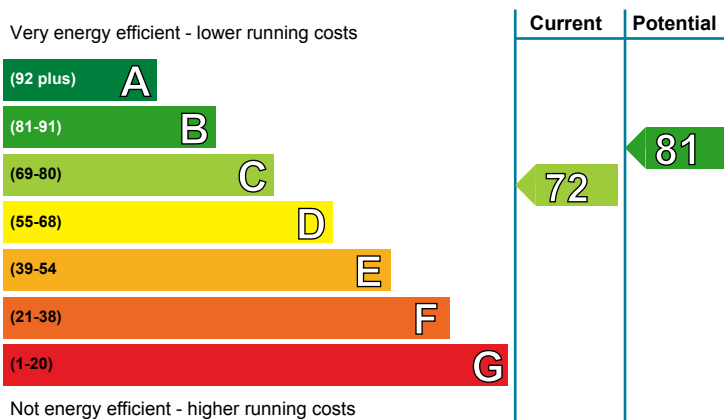
## Energy Efficiency Rating

This graph shows the current efficiency of your home, taking into account both energy efficiency and fuel costs. The higher this rating, the lower your fuel bills are likely to be.

Your current rating is **band C (72)**. The average rating for EPCs in Scotland is **band D (61)**.

The potential rating shows the effect of undertaking all of the improvement measures listed within your recommendations report.
