HOME REPORT

**6 EAST PILTON FARM WYND
EDINBURGH
EH5 2GJ**

Lyndsay Gowans, MA (Hons) MRICS

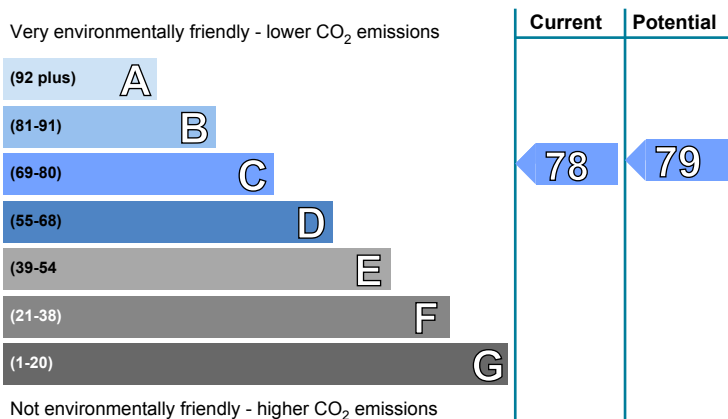
Environmental Impact (CO₂) Rating

This graph shows the effect of your home on the environment in terms of carbon dioxide (CO₂) emissions. The higher the rating, the less impact it has on the environment.
