Home Report

Scottish Single Survey

Property address	31 Inveresk Village Musselburgh EH21 7TD
-------------------------	--

Prepared by	Shepherd Chartered Surveyors
--------------------	------------------------------

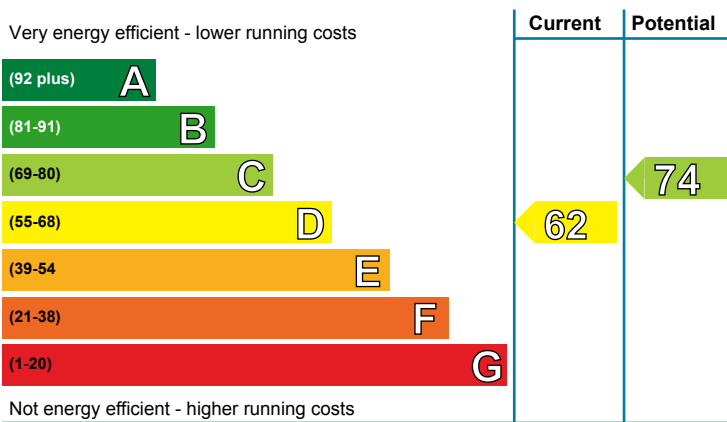
Energy Efficiency Rating

This graph shows the current efficiency of your home, taking into account both energy efficiency and fuel costs. The higher this rating, the lower your fuel bills are likely to be.

Your current rating is **band D (62)**. The average rating for EPCs in Scotland is **band D (61)**.

The potential rating shows the effect of undertaking all of the improvement measures listed within your recommendations report.

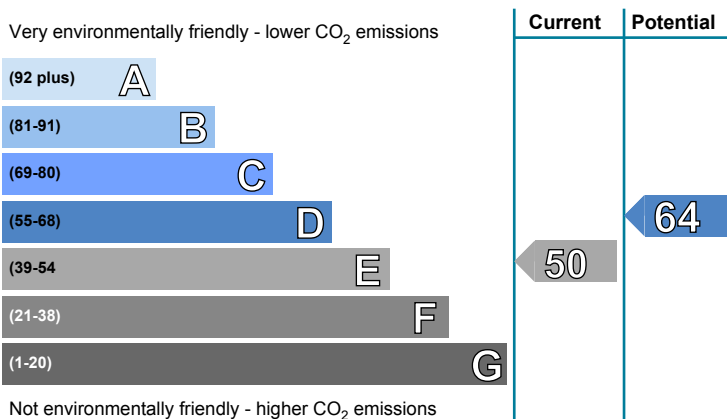
Environmental Impact (CO₂) Rating

This graph shows the effect of your home on the environment in terms of carbon dioxide (CO₂) emissions. The higher the rating, the less impact it has on the environment.
