# Home Report

22/1 Oxford Street  
Edinburgh EH8 9PL

# Single Survey

<b>Property Address</b>	22/1 Oxford Street Edinburgh EH8 9PL
<b>Customer</b>	The late Julia Hill
<b>Prepared by</b>	Graham + Sibbald Property Consultants Limited
<b>Date of Inspection</b>	13/05/2026

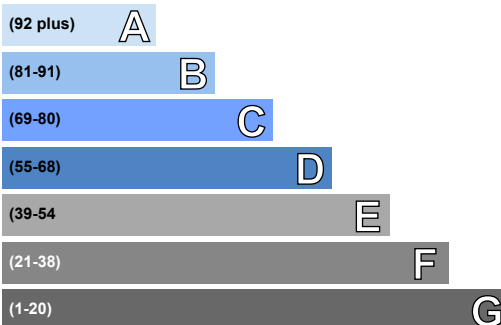
## Environmental Impact (CO<sub>2</sub>) Rating

Current	Potential
68	76

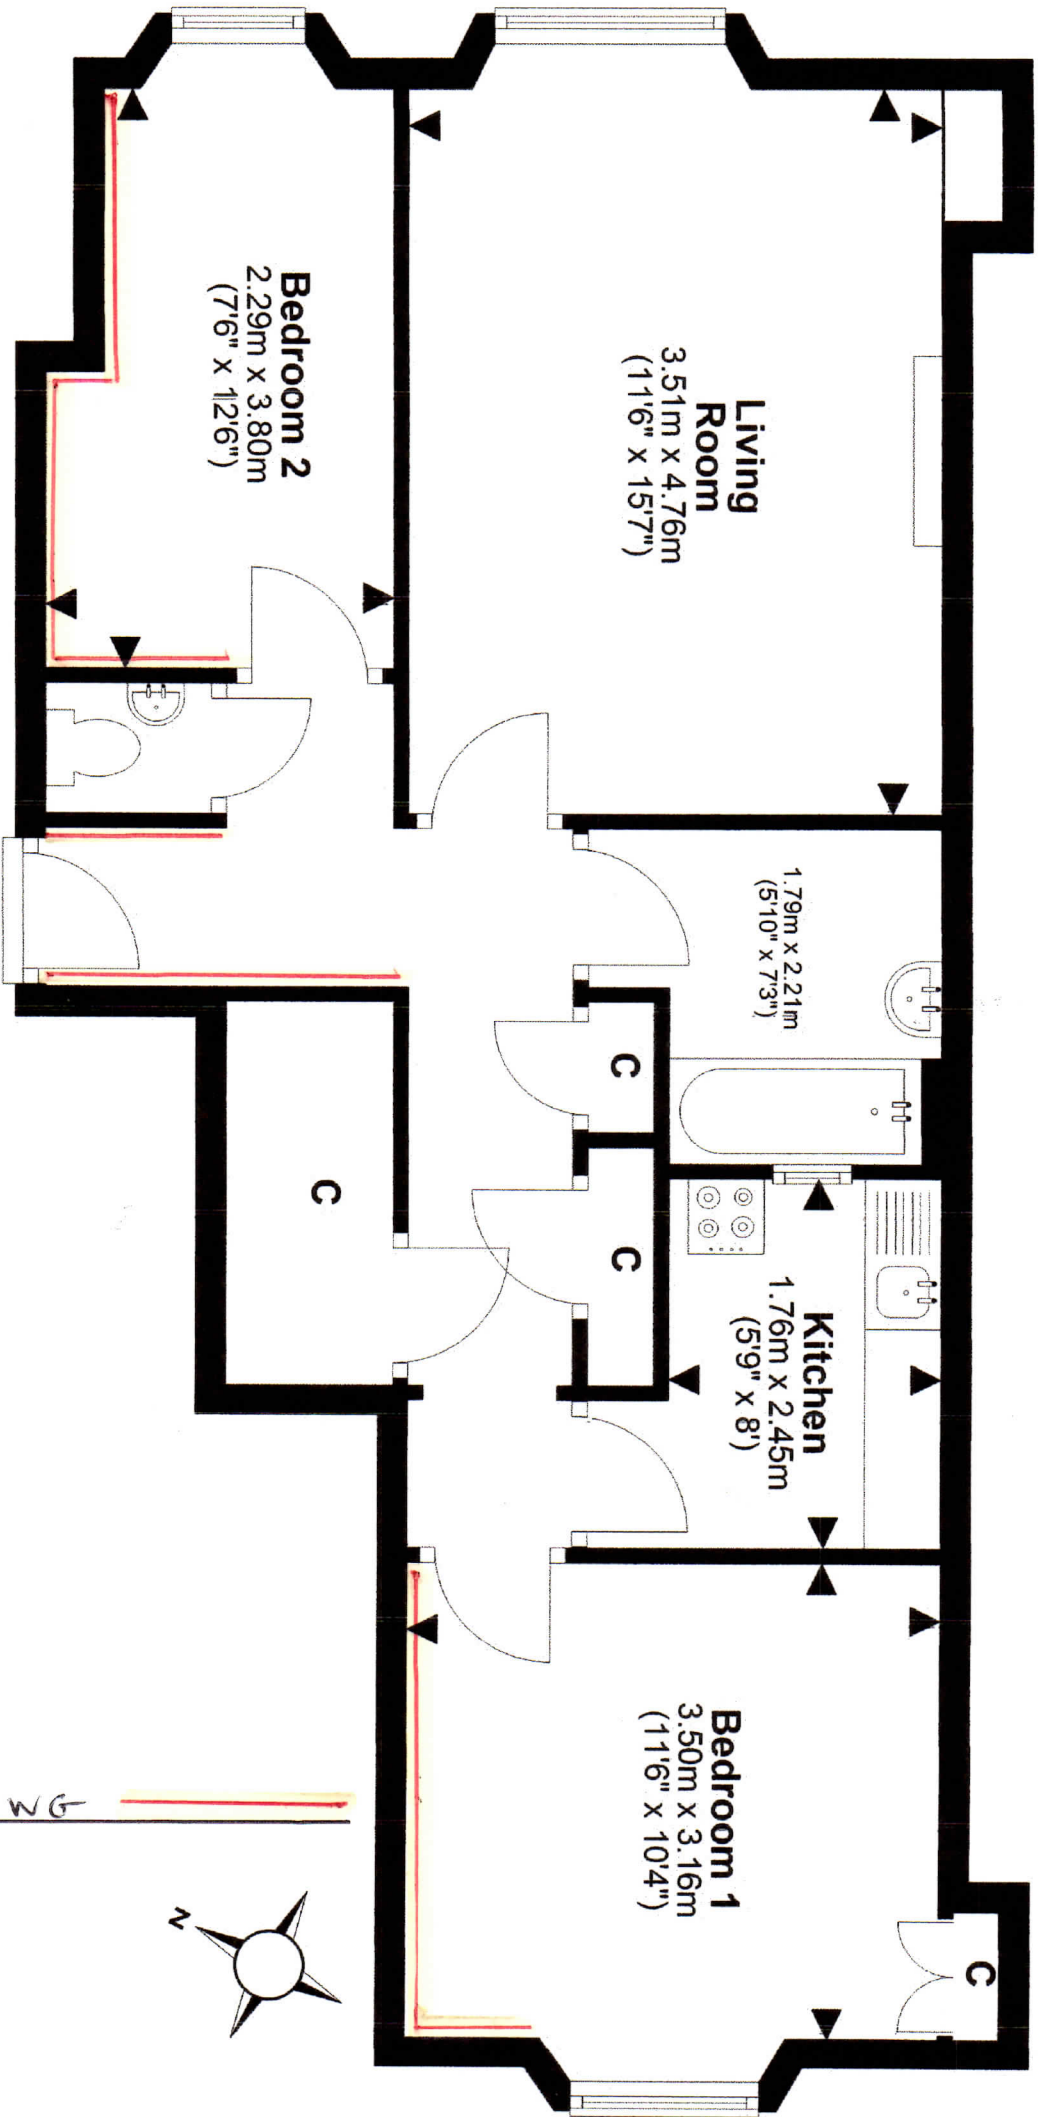
This plan is for illustrative purposes only and should only be used as such by a prospective purchaser.  
 For details of the internal floor area, please refer to the Home Report.
