Home Report

30/1 Kirk Street
Edinburgh EH6 5EZ

Single Survey

Property Address	30/1 Kirk Street Edinburgh EH6 5EZ
Customer	Rebecca & David Forbes
Prepared by	Graham + Sibbald Property Consultants Limited
Date of Inspection	19/05/2026

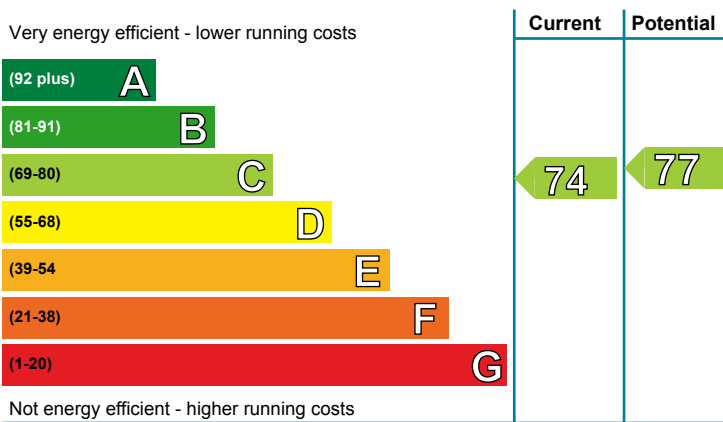
Energy Efficiency Rating

This graph shows the current efficiency of your home, taking into account both energy efficiency and fuel costs. The higher this rating, the lower your fuel bills are likely to be.

Your current rating is **band C (74)**. The average rating for EPCs in Scotland is **band D (61)**.

The potential rating shows the effect of undertaking all of the improvement measures listed within your recommendations report.

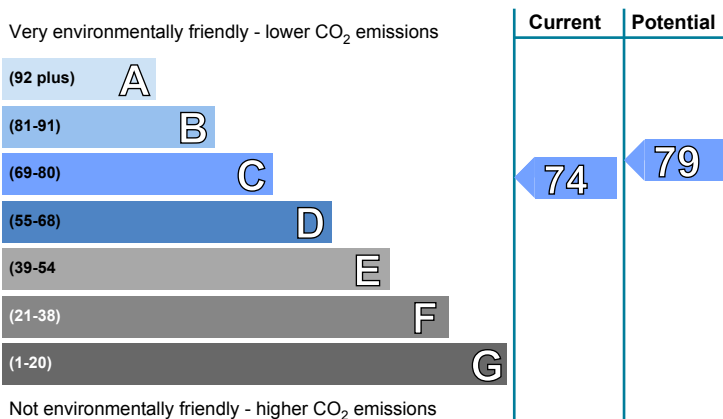
Environmental Impact (CO₂) Rating

This graph shows the effect of your home on the environment in terms of carbon dioxide (CO₂) emissions. The higher the rating, the less impact it has on the environment.
