Home Report

Scottish Single Survey

Property address	6 Joppa Terrace Edinburgh EH15 2HY
-------------------------	--

Prepared by	Shepherd Chartered Surveyors
--------------------	------------------------------

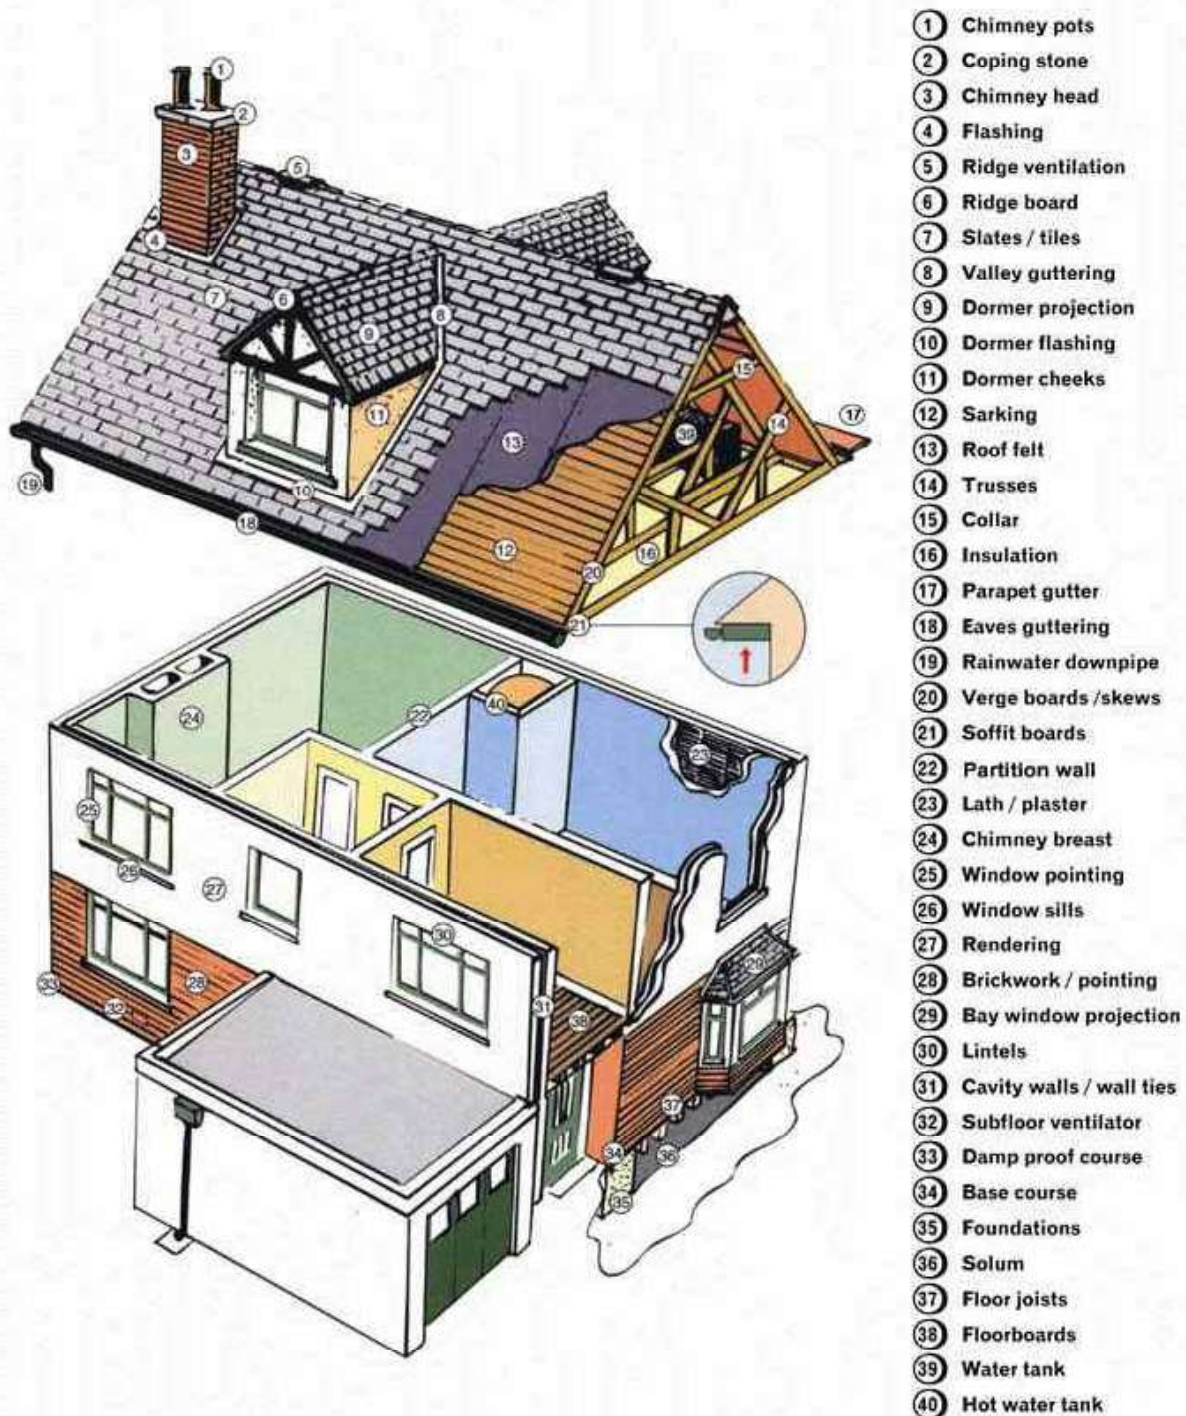
Sectional Diagram showing elements of a typical house

Reference may be made in this report to some or all of the above component parts of the property. This diagram may assist you in locating and understanding these items.

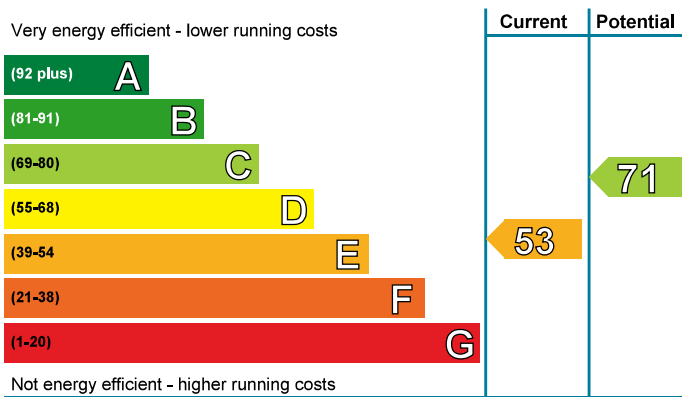
Energy Efficiency Rating

This graph shows the current efficiency of your home, taking into account both energy efficiency and fuel costs. The higher this rating, the lower your fuel bills are likely to be.

Your current rating is **band E (53)**. The average rating for EPCs in Scotland is **band D (61)**.

The potential rating shows the effect of undertaking all of the improvement measures listed within your recommendations report.

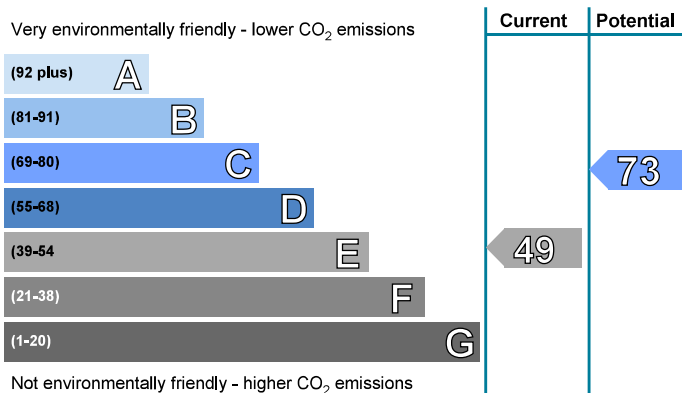
Environmental Impact (CO₂) Rating

This graph shows the effect of your home on the environment in terms of carbon dioxide (CO₂) emissions. The higher the rating, the less impact it has on the environment.
