Home Report

36 Cambridge Avenue
Edinburgh EH6 5AP

Single Survey

Property Address	36 Cambridge Avenue Edinburgh EH6 5AP
Customer	Graham Marchbank & Amanda Tirvengadum
Prepared by	Graham + Sibbald Property Consultants Limited
Date of Inspection	20/05/2026

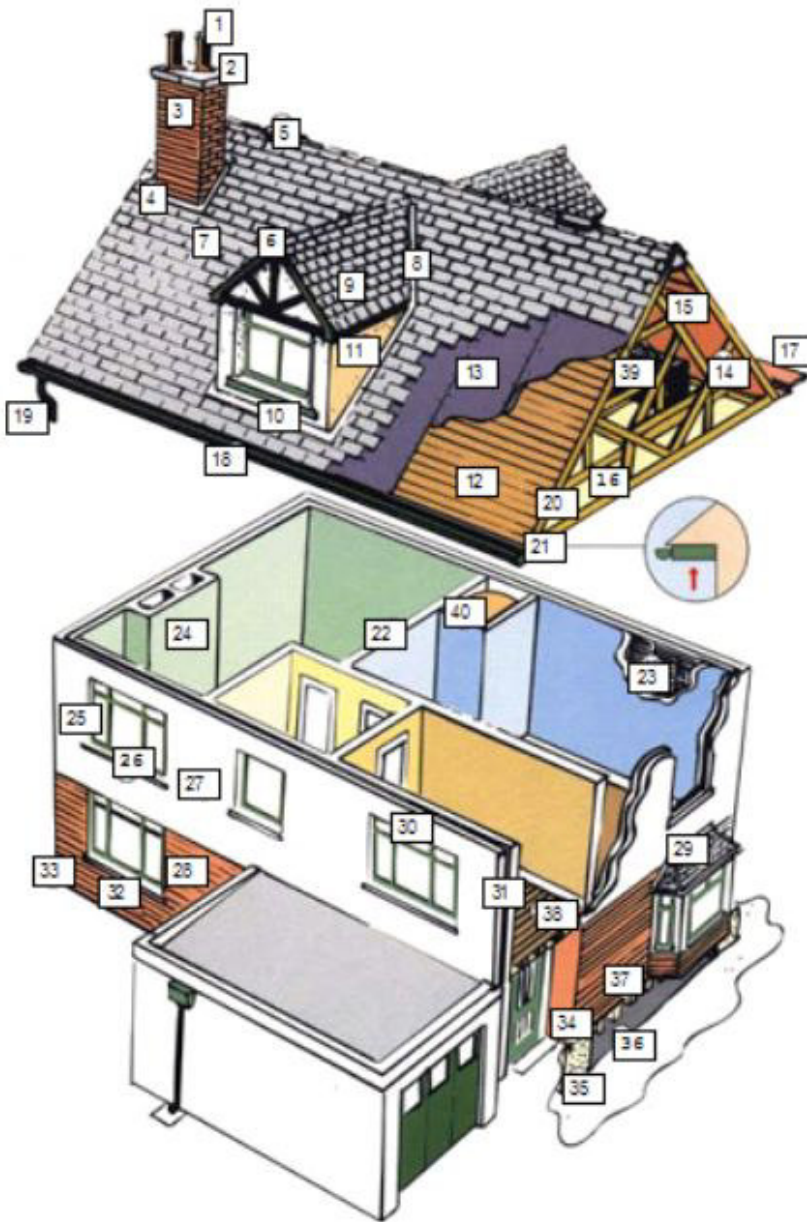
Sectional diagram showing elements of a typical house

1	Chimney pots
2	Coping stone
3	Chimney head
4	Flashing
5	Ridge ventilation
6	Ridge board
7	Slates / tiles
8	Valley guttering
9	Dormer projection
10	Dormer flashing
11	Dormer cheeks
12	Sarking
13	Roof felt
14	Trusses
15	Collar
16	Insulation
17	Parapet gutter
18	Eaves guttering
19	Rainwater downpipe
20	Verge boards / skews
21	Soffit boards
22	Partition wall
23	Lath / plaster
24	Chimney breast
25	Window pointing
26	Window sills
27	Rendering
28	Brickwork / pointing
29	Bay window projection
30	Lintels
31	Cavity walls / wall ties
32	Subfloor ventilator
33	Damp proof course
34	Base course
35	Foundations
36	Solum
37	Floor joists
38	Floorboards
39	Water tank
40	Hot water tank

Reference may be made in this report to some or all of the above component parts of the property. This diagram may assist you in locating and understanding these items.

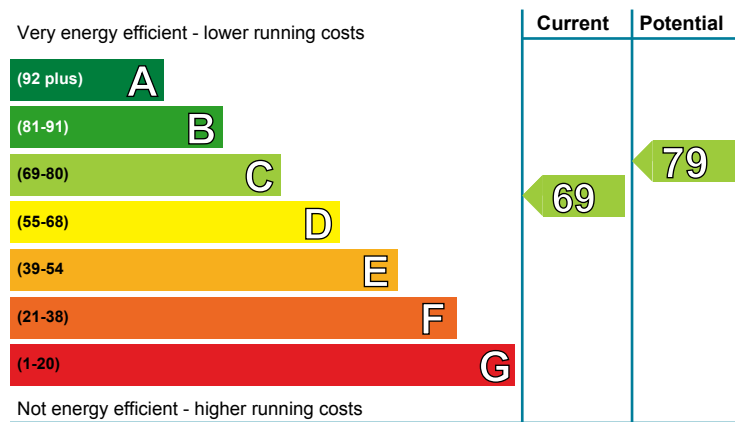
Energy Efficiency Rating

This graph shows the current efficiency of your home, taking into account both energy efficiency and fuel costs. The higher this rating, the lower your fuel bills are likely to be.

Your current rating is **band C (69)**. The average rating for EPCs in Scotland is **band D (61)**.

The potential rating shows the effect of undertaking all of the improvement measures listed within your recommendations report.

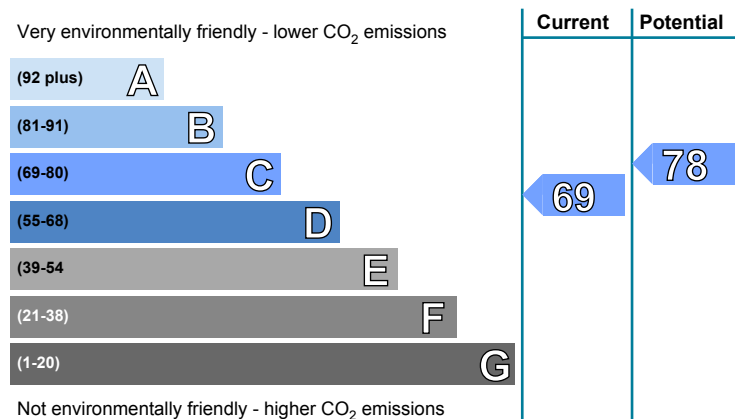
Environmental Impact (CO₂) Rating

This graph shows the effect of your home on the environment in terms of carbon dioxide (CO₂) emissions. The higher the rating, the less impact it has on the environment.
