HOME REPORT

Inch Cottage,
2 Dunfermline Road,
Limekilns,
Dunfermline,
Fife,
KY11 3JS

Single Survey

Survey Report on:

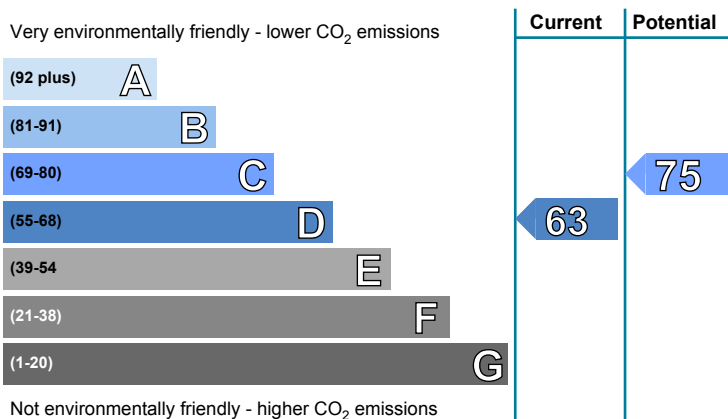
Environmental Impact (CO₂) Rating

This graph shows the effect of your home on the environment in terms of carbon dioxide (CO₂) emissions. The higher the rating, the less impact it has on the environment.
