Home Report

20/1 Edina Place
Edinburgh EH7 5RR

Single Survey

Property Address	20/1 Edina Place Edinburgh EH7 5RR
Customer	The estate of the late Mrs Robertina Dobbin
Prepared by	Graham + Sibbald Property Consultants Limited
Date of Inspection	02/06/2026

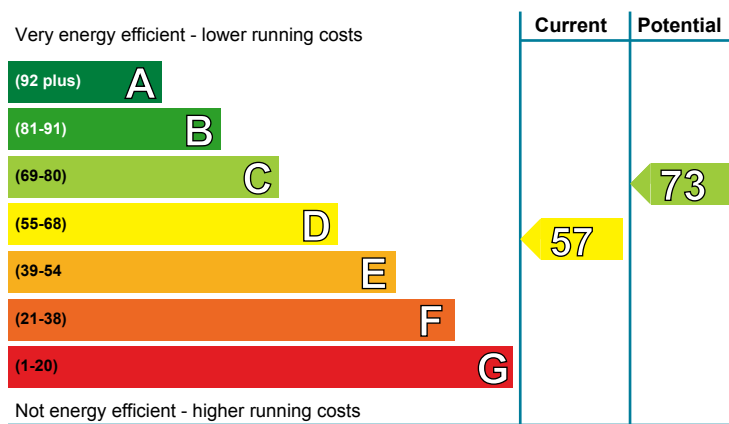
Energy Efficiency Rating

This graph shows the current efficiency of your home, taking into account both energy efficiency and fuel costs. The higher this rating, the lower your fuel bills are likely to be.

Your current rating is **band D (57)**. The average rating for EPCs in Scotland is **band D (61)**.

The potential rating shows the effect of undertaking all of the improvement measures listed within your recommendations report.

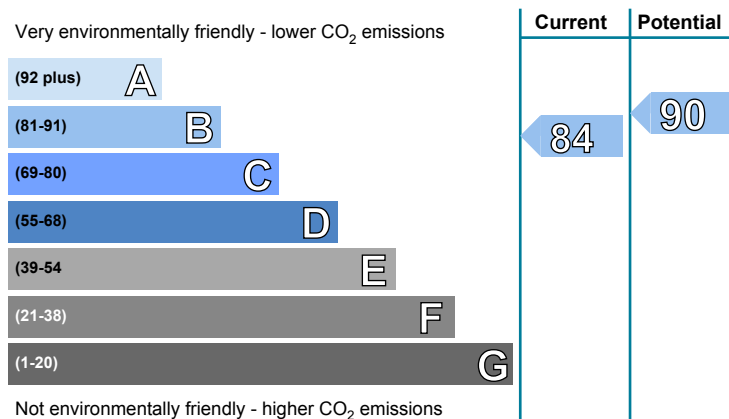
Environmental Impact (CO₂) Rating

This graph shows the effect of your home on the environment in terms of carbon dioxide (CO₂) emissions. The higher the rating, the less impact it has on the environment.
