# Home Report

40 Clermiston Road North  
Edinburgh EH4 7BN

# Single Survey

<b>Property Address</b>	40 Clermiston Road North Edinburgh EH4 7BN
<b>Customer</b>	The late Julia Hill
<b>Prepared by</b>	Graham + Sibbald Property Consultants Limited
<b>Date of Inspection</b>	04/06/2026

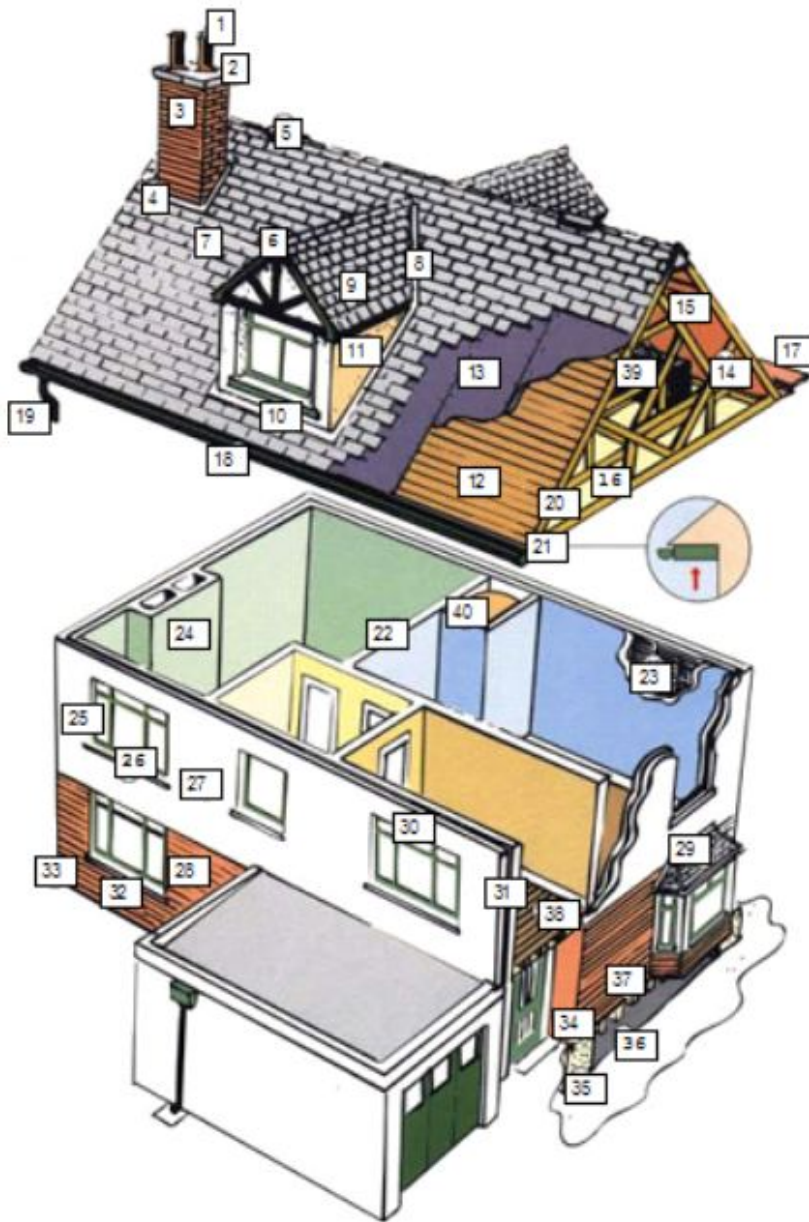
## Sectional diagram showing elements of a typical house

1	Chimney pots
2	Coping stone
3	Chimney head
4	Flashing
5	Ridge ventilation
6	Ridge board
7	Slates / tiles
8	Valley guttering
9	Dormer projection
10	Dormer flashing
11	Dormer cheeks
12	Sarking
13	Roof felt
14	Trusses
15	Collar
16	Insulation
17	Parapet gutter
18	Eaves guttering
19	Rainwater downpipe
20	Verge boards / skews
21	Soffit boards
22	Partition wall
23	Lath / plaster
24	Chimney breast
25	Window pointing
26	Window sills
27	Rendering
28	Brickwork / pointing
29	Bay window projection
30	Lintels
31	Cavity walls / wall ties
32	Subfloor ventilator
33	Damp proof course
34	Base course
35	Foundations
36	Solum
37	Floor joists
38	Floorboards
39	Water tank
40	Hot water tank

Reference may be made in this report to some or all of the above component parts of the property. This diagram may assist you in locating and understanding these items.

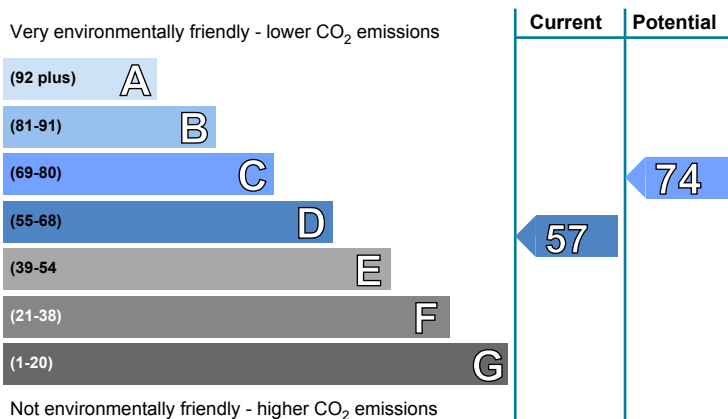
## Environmental Impact (CO<sub>2</sub>) Rating

This graph shows the effect of your home on the environment in terms of carbon dioxide (CO<sub>2</sub>) emissions. The higher the rating, the less impact it has on the environment.
