# HOME REPORT

111 Dewar Street  
Dunfermline  
KY12 8AB

# Single Survey

## Survey Report on:

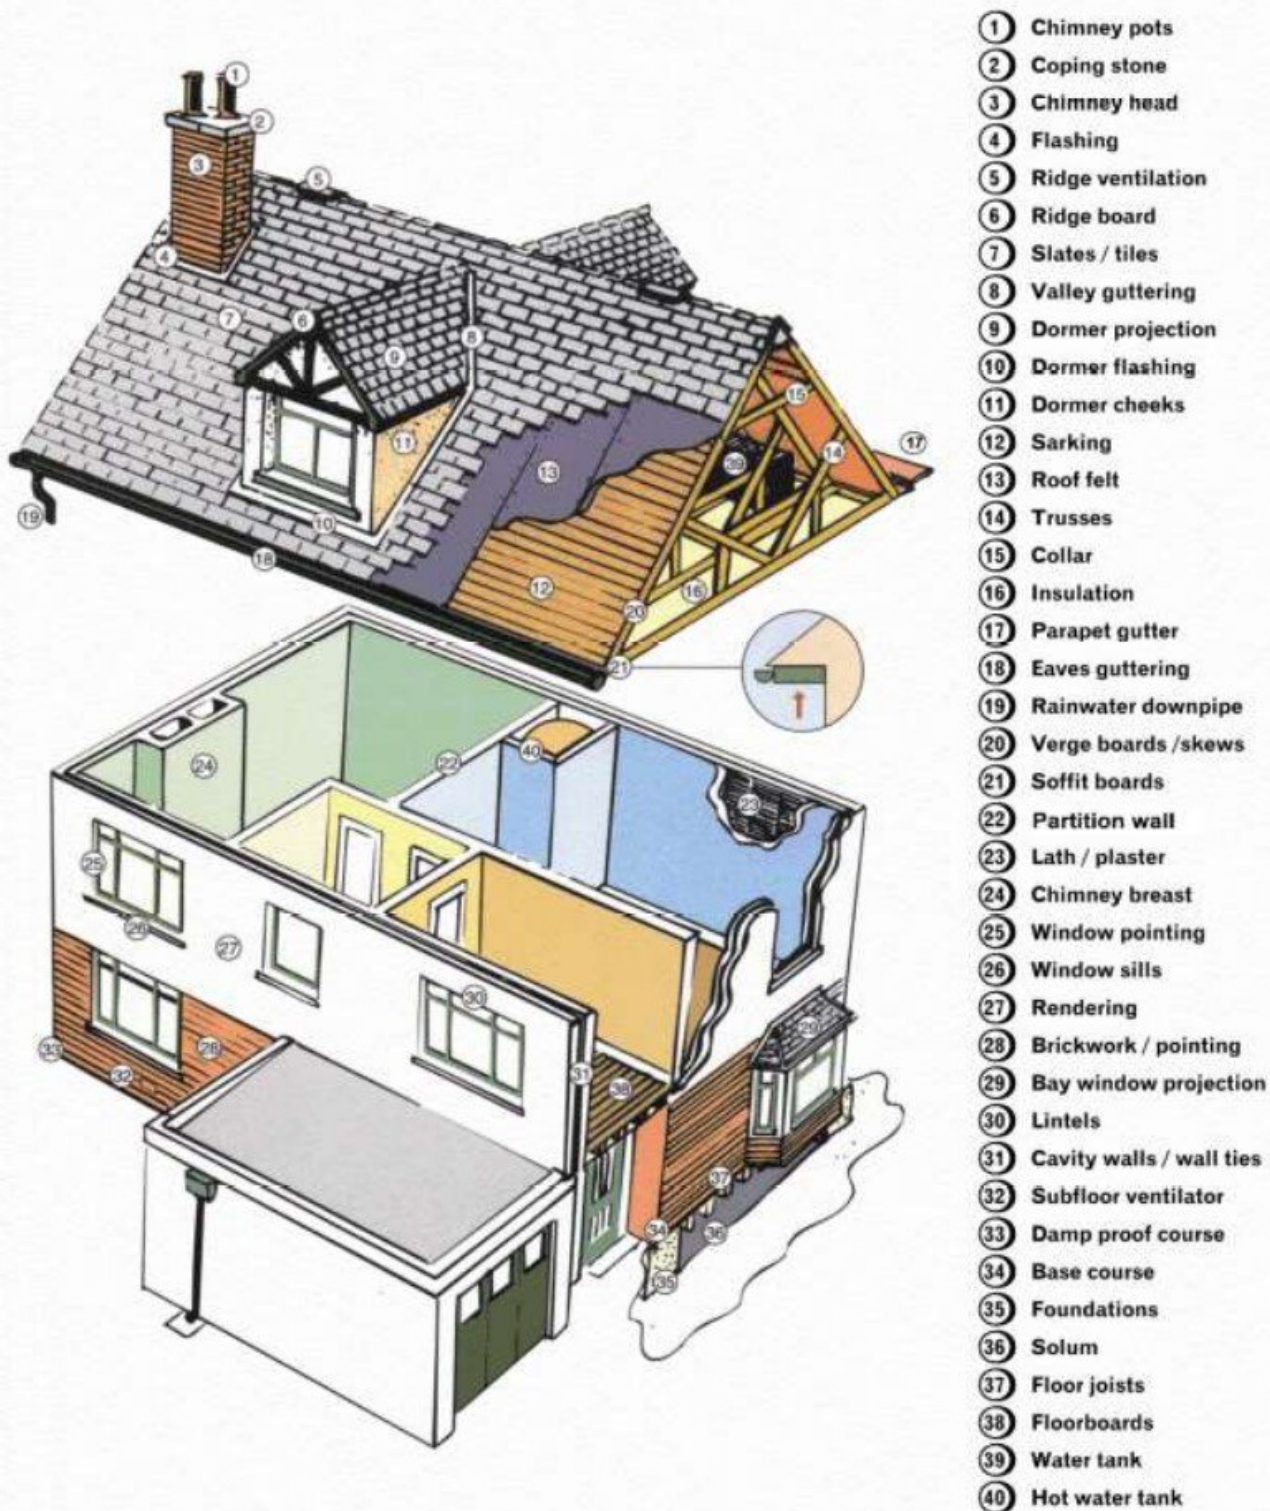
## Sectional Diagram showing elements of a typical house

Reference may be made in this report to some or all of the above component parts of the property. This diagram may assist you in locating and understanding these items.
