# YOUR ONESURVEY HOME REPORT

60 Woodside Avenue  
Rosyth  
Dunfermline  
KY11 2LA

# SINGLE SURVEY

# Single Survey

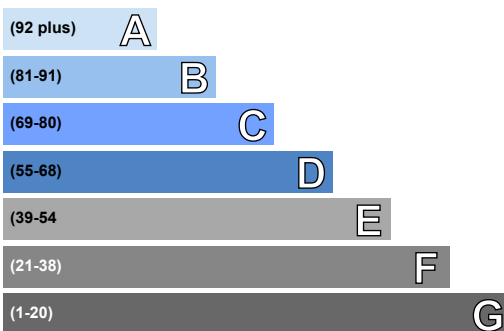
Very environmentally friendly - lower CO<sub>2</sub> emissions

| Current | Potential |
| 37 | 63 |
